Delaware Water Gap National Recreation Area High Angle Rescue Training Accident Facilitated Learning Analysis High Point State Park (NJ)

Incident Date: April 8, 2015

US Department of the Interior
National Park Service

Delaware Water Gap National Recreation Area High Angle Rescue Training Accident Facilitated Learning Analysis

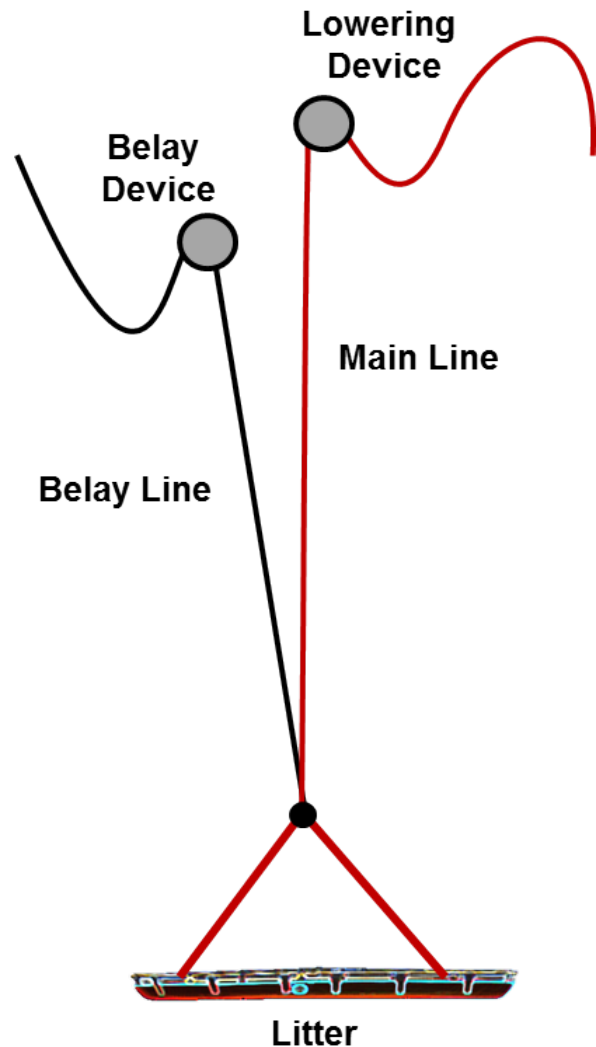
The main line was routed from a hauling pulley system up through a high directional comprised of two locking carabiners anchored at the next level above with nylon webbing to the handrail structure. A separate managed belay line (backup) was not employed.

Figure 1- Two rope rescue system employing main line and belay line. Litter attendant not shown for clarity.

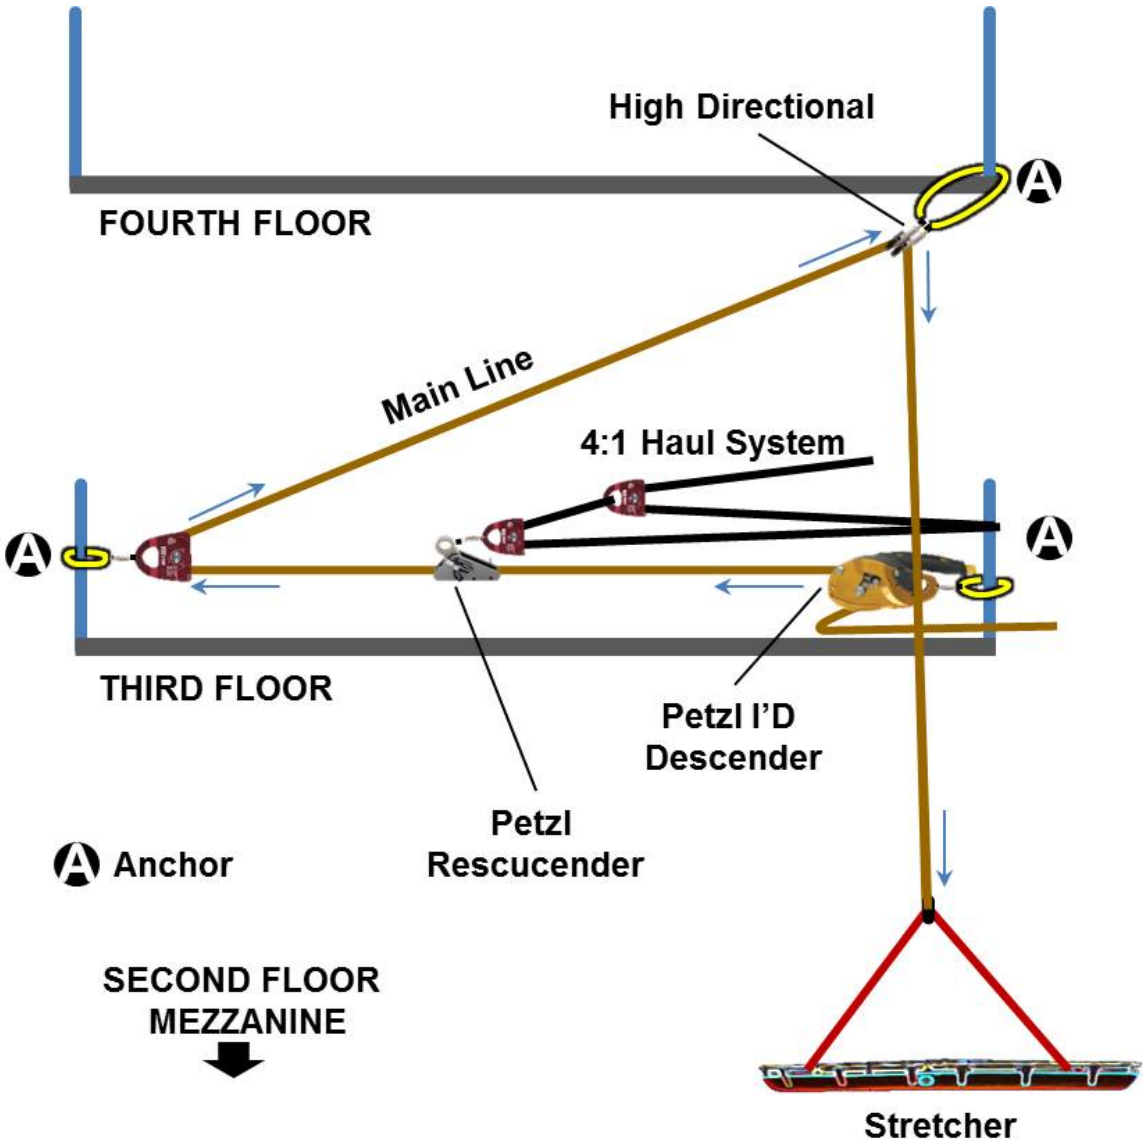
Figure 4- Schematic diagram of accident scene rigging. Not drawn to scale.

The ATL noted, at the time prior to the accident, that “this configuration introduced the potential for significant slack if the directional failed.”

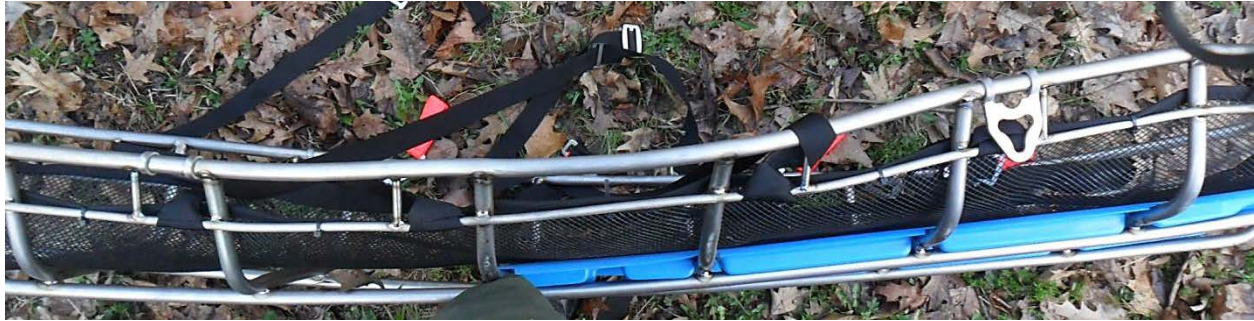
The violent impact caused the left rail of the titanium litter to become dramatically bent and the mesh liner in the litter ripped. The ATL later observed, “If I was in the lower attendant position I’d be dead, I’m quite sure of that.”

Figure 6- Damaged rescue litter following accident.

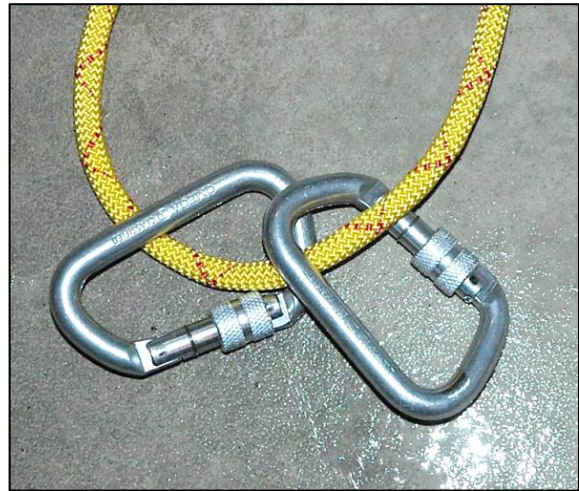
The two carabiners, which had been used as a directional, were found attached to the main line rope lying on the mezzanine floor.

Figure 7- Carabiners, used for high directional, on the main line following the accident.

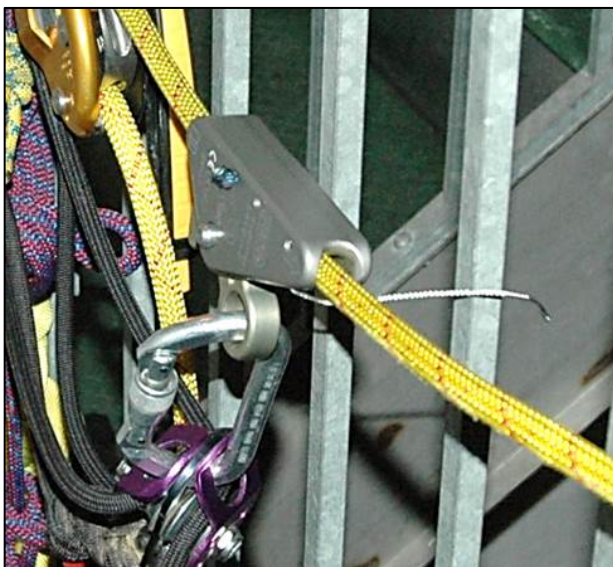
Post-accident it was observed that the Petzl Rescucender, which was the attachment for the 4:1 hauling system to the main line, had a wire sticking out of it. The wire is a non-load bearing component that serves as a “keeper” to prevent the loss of the internal cam when the device is being loaded on the rope. Although not precisely known, this physical damage is assumed to have been caused by the sudden release of tension and the device striking the handrail structure. This likely occurred following the catastrophic anchor point failure above.

Figure 8- Damaged Rescucender showing broken retention wire.

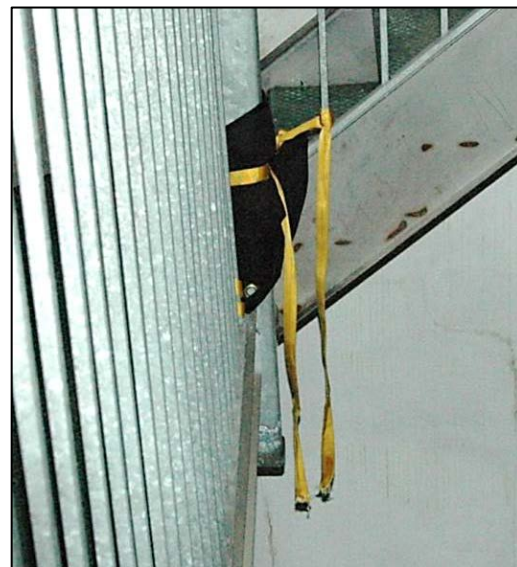
During the on-scene examination of the upper anchor point, it was observed that the nylon webbing had made contact with an exposed edge of angle iron. This occurred when the tensioned main line created a resultant force on the high directional that pulled it at an offset angle away from directly below the upright corner stanchion post.

Later it was summarized that the webbing anchor was also not securely tied off with a “master point” of attachment. It was described that “one cut could cause the whole system to fail.”

Figure 9- Upper anchor point following failure of nylon webbing.

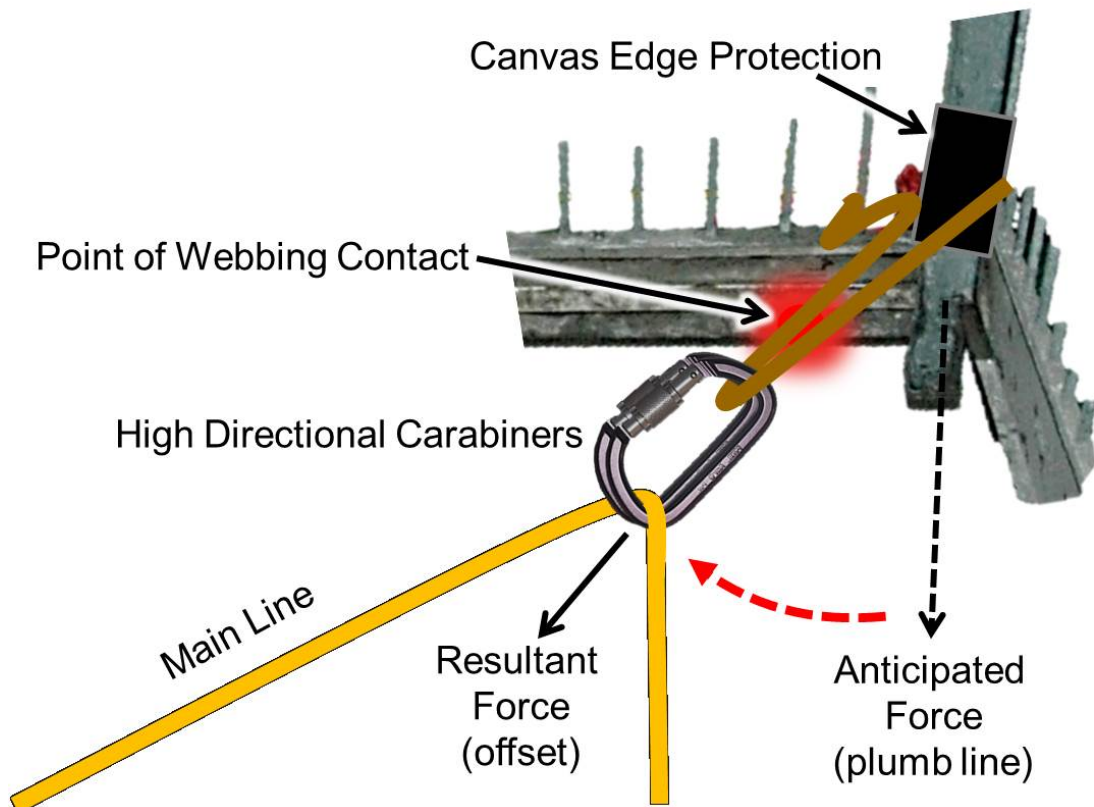
Figure 10- Diagram demonstrating offset resultant force created by tensioned main line.

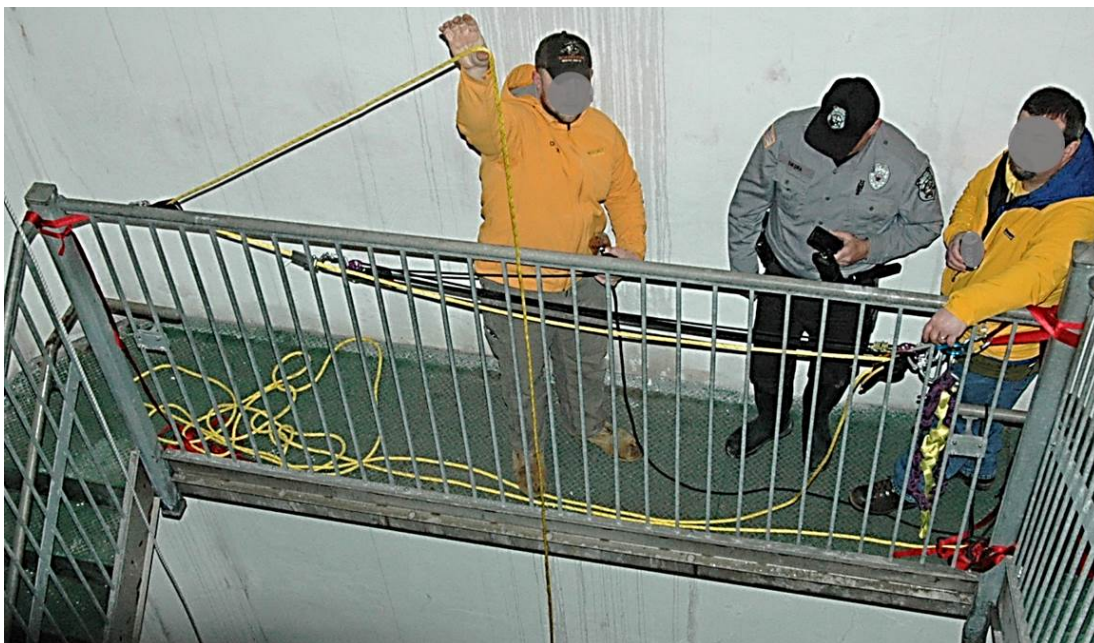
Figure 11- Haul system and lowering rigging post-accident.
