Delaware Water Gap National Recreation Area High Angle Rescue Training Accident Facilitated Learning Analysis High Point State Park (NJ)

Incident Date: April 8, 2015

US Department of the Interior
National Park Service

Delaware Water Gap National Recreation Area High Angle Rescue Training Accident Facilitated Learning Analysis

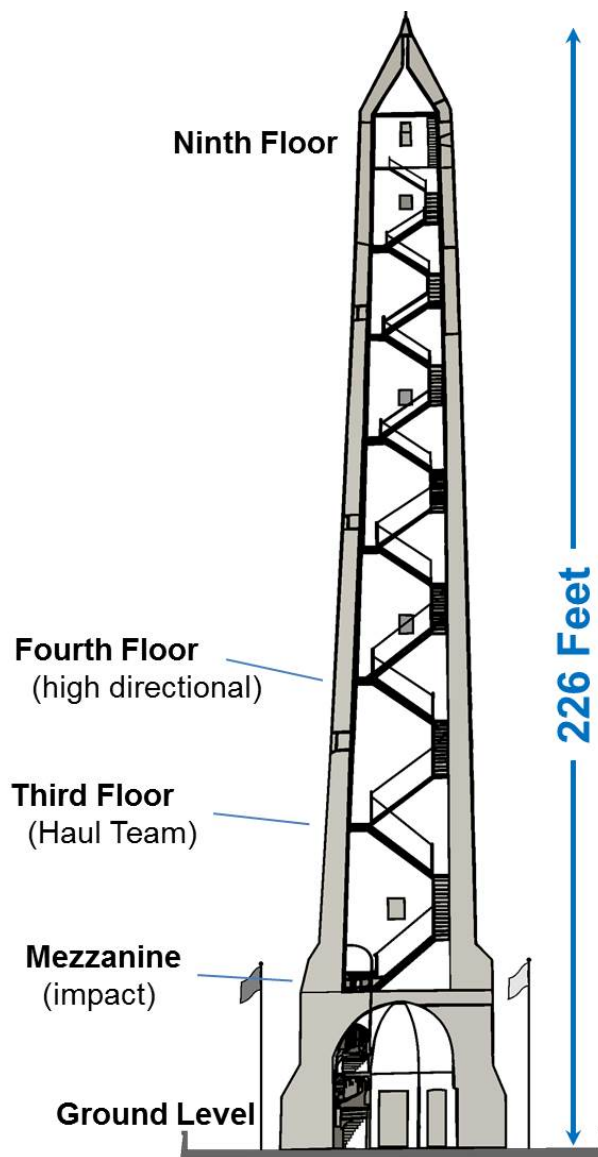
Figure 2- Structural diagram of Monument at High Point State Park (NJ).

As they were walking into the Monument, the TL told the ATL to “punch in the rigging above.” The TL reminded ATL that there were no rocks or trees, “you have the lead.” The ATL responded, “no problem, I got this.” The distance between floors (horizontal landings) is 26.5 feet. The ATL climbed up two levels above and set up rigging for a high directional, which would wind up being one level above the hauling system.

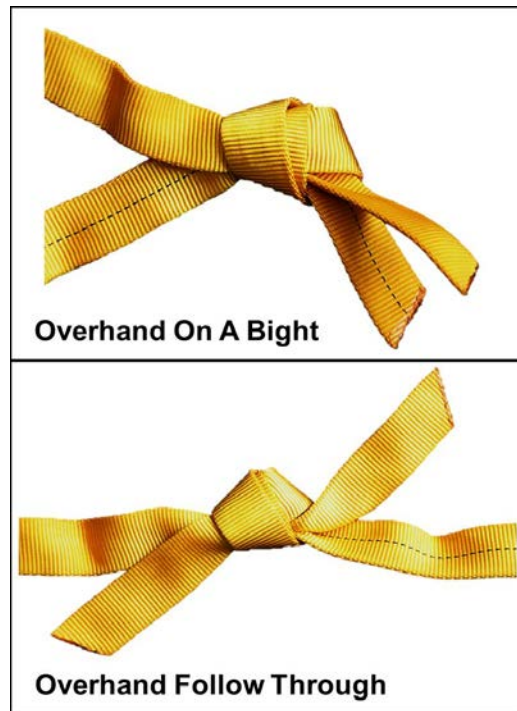
Figure 3- Overhand on a bight and overhand follow through.

Initially Rescuer 3 rigged the upper anchor for the directional, however the ATL inspected the rigging and found it was tied incorrectly. The webbing was tied with an overhand on a bight (tails come out together). The anchor webbing was kept in place and the ATL re-tied the knot. The knot was properly retied with an overhand follow (ring bend) that is noticeably different (tails come out in opposite directions). The webbing tails were then secured with “half hitches on the tails”.

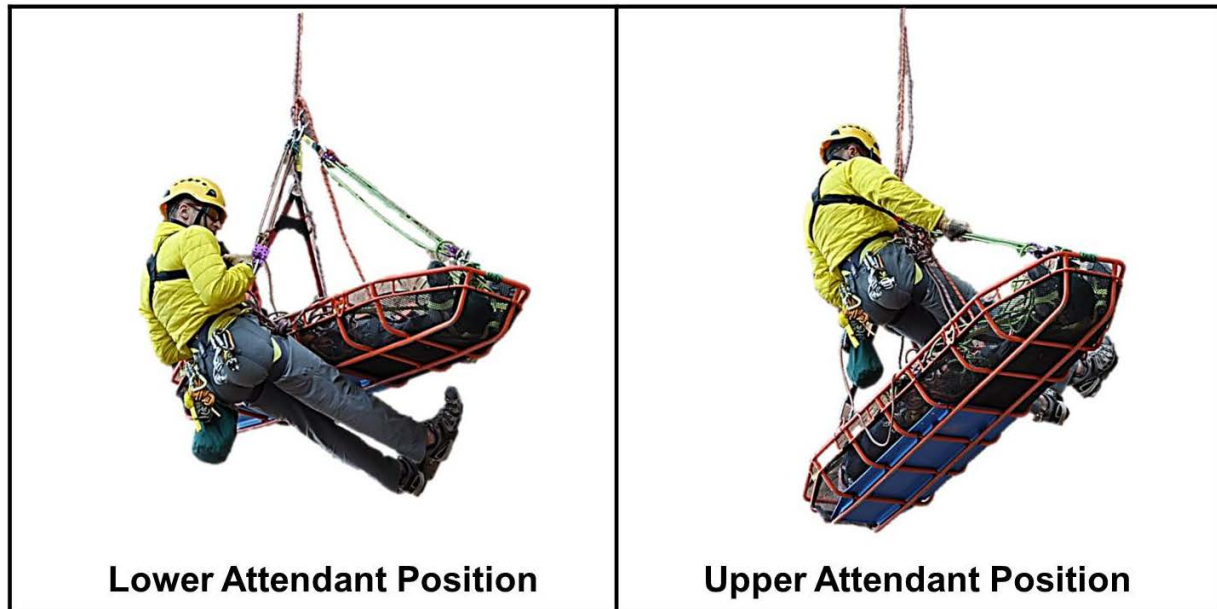
Figure 5- Example images of the lower and upper attendant positions.

The training commenced with litter attendants practicing operating in the lower traditional attendant position and more efficient upper attendant positions (Figure 5)
